Cush Wind Farm  
Phase II

Environmental Impact  
Assessment Report

**Galros Bog**

**Draft Cutaway Bog Decommissioning  
and Rehabilitation Plan  
2026**

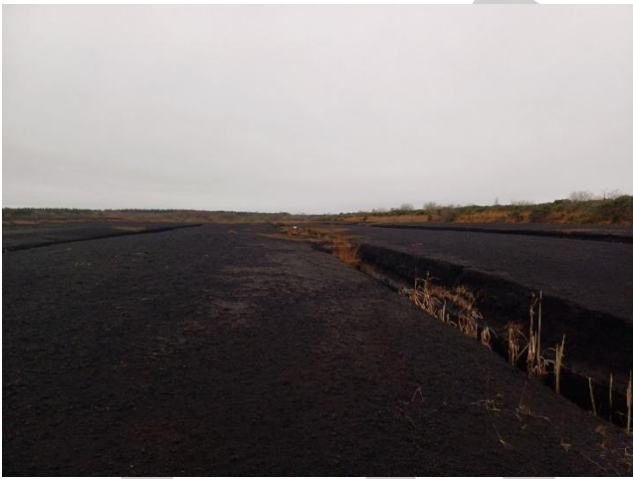
Table 3-1: Photos of Habitats at Galros

| Photos of Habitats at Galros (2024) | |
|---|---|
| <i>Bare peat (BP) the most commonly occurring habitat at Galros.</i> | <i>Pioneer Eriophorum angustifolium (pEang) or Carex rostrata community (pRos) in NW of Galros.</i> |

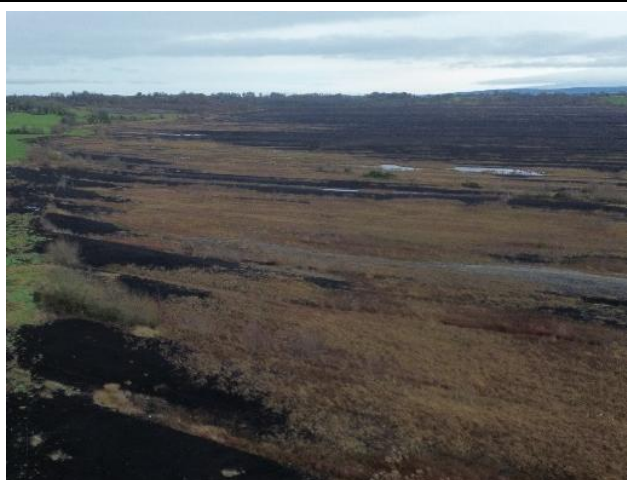
Aerial of pioneer *Eriophorum angustifolium* (pEang) and *Carex rostrata* community (pRos) in NW of Galros.

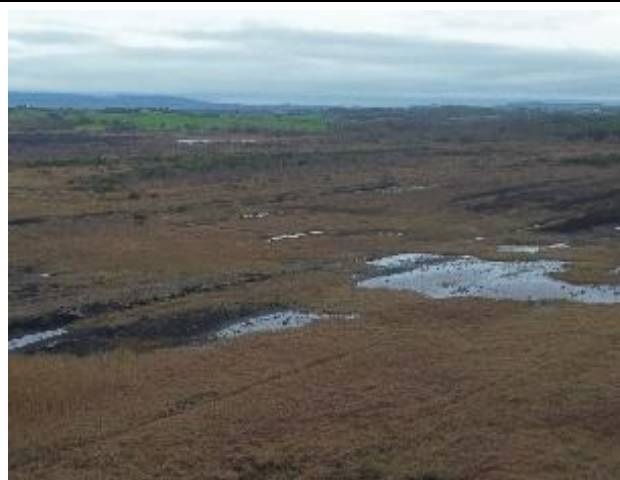
Aerial of pioneer *Eriophorum angustifolium* (pEang) and *Carex rostrata* community (pRos) and Pioneer open habitats and scrub in W of Galros.

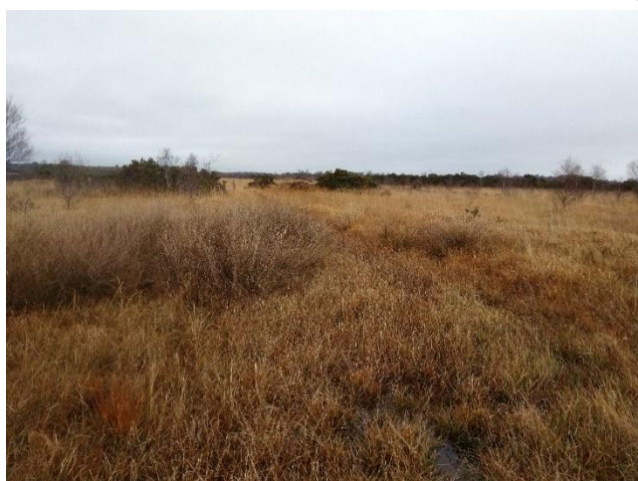
Rich fen *Schoenus nigricans* (Pschon) (rudimentary rich fen), *Eriophorum angustifolium* (pEang) and *Carex demissa* (pVir) in SW of Galros.

There is a small area of production-related cutaway located in the south-west part of the site. This area occupies some of the lowest ground in Galros. Thick Marl is exposed in the filled drains though this area. It is mainly vegetated by wet poor fen vegetation dominated by Yellow Sedge and Bottle Sedge (pVir/pRos). Several small patches of Black Bog-rush are present within this area and some *Scorpidium scorpioides* (rich fen indicator) was also found. Other species present include Purple Moorgrass (along edges of drains where it is drier), Marsh Pennywort, Ragged Robin, Marsh Bedstraw, Reedmace, Bog Thistle, Devil's-Bit, Angelica, Purple loosestrife, Lousewort, Butterwort, Knapweed, Common Century, Meadowsweet, Sweet vernal-grass, Yorkshire Fog and Lesser Spearwort. The moss layer is dominated by *Calliergonella cuspidata* and *Fissidens* sp. are also frequent. Birch and Eared Willow are scattered through this area and have colonised along drains. Soft Rush was present but was rare in occurrence. This wetland vegetation is not unlike the small area of potential rich fen found in Clongawny.

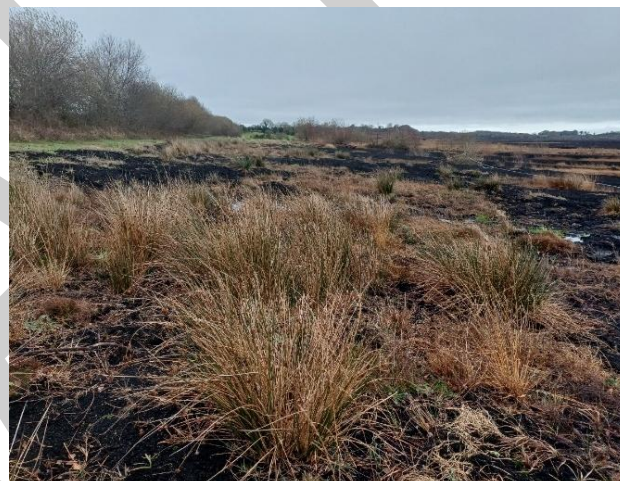
Pioneer open habitats with *Eriophorum angustifolium* community (acidic) (pEang), pioneer *Juncus effusus* community (pJeff) and pioneer *Juncus bulbosus* community (pJbulb).

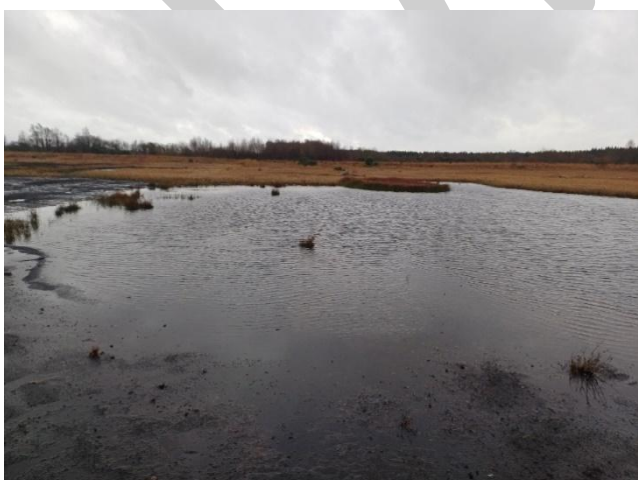
Wetlands with pioneer *Eriophorum angustifolium* (pEang), *Carex rostrata* community (pRos) and open water (OW) in S Galros.

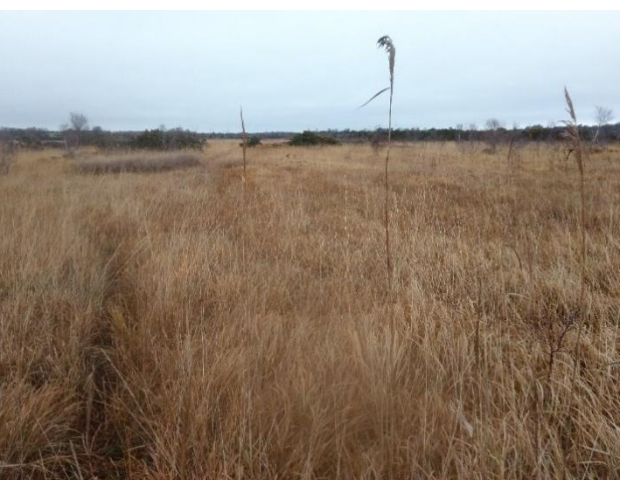
Molina dominated grassland in S Galros.

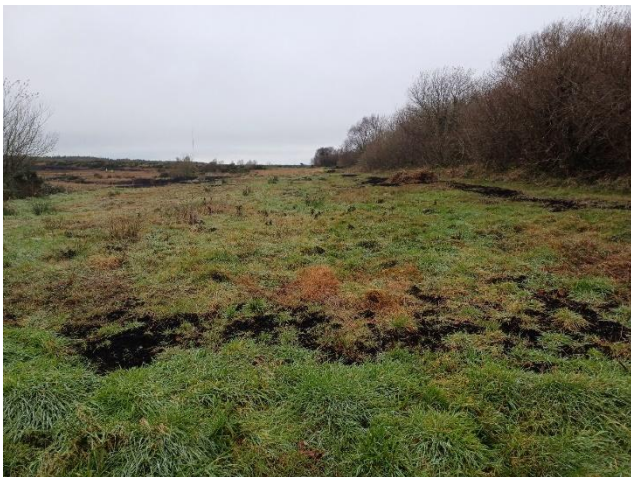
Area of pioneer *Dactylis-Arrhenatherum* grassland community (gDact-Arr) in N Galros.

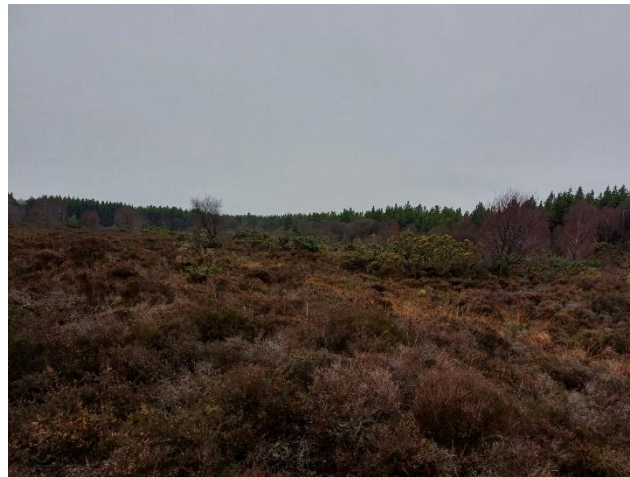
Remnant high bog with heather dominated vegetation. Area drained but never industrially cut, in S Galros.

The only area of remnant high bog (PB1) found around the margins is in the south-east corner of the site. This Small area is now degraded and dried out and was probably also used to cut turf in the past. This area is also fenced off. The northern boundary also has some remnant marginal high bog but these areas have also been

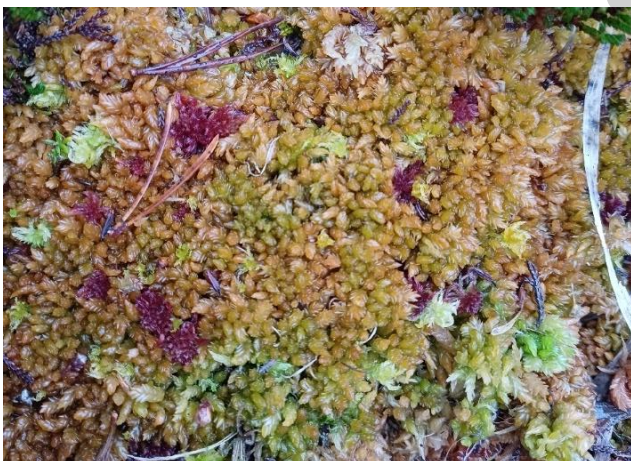
*Sphagnum paoillosum* hummock in remnant high bog with heather dominated vegetation in E Galros.

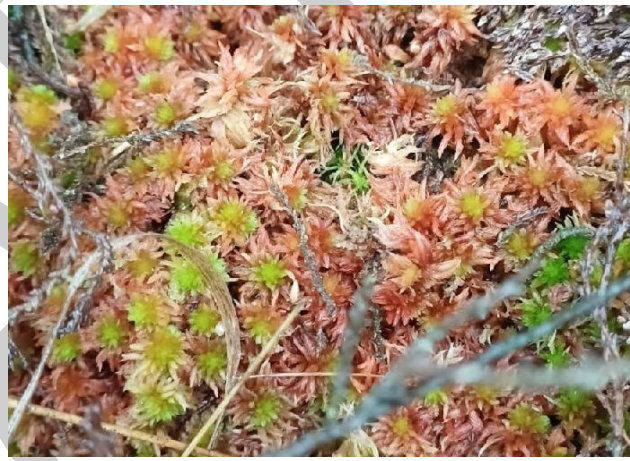
*Sphagnum subnitens* hummock in remnant high bog with heather dominated vegetation in E Galros.

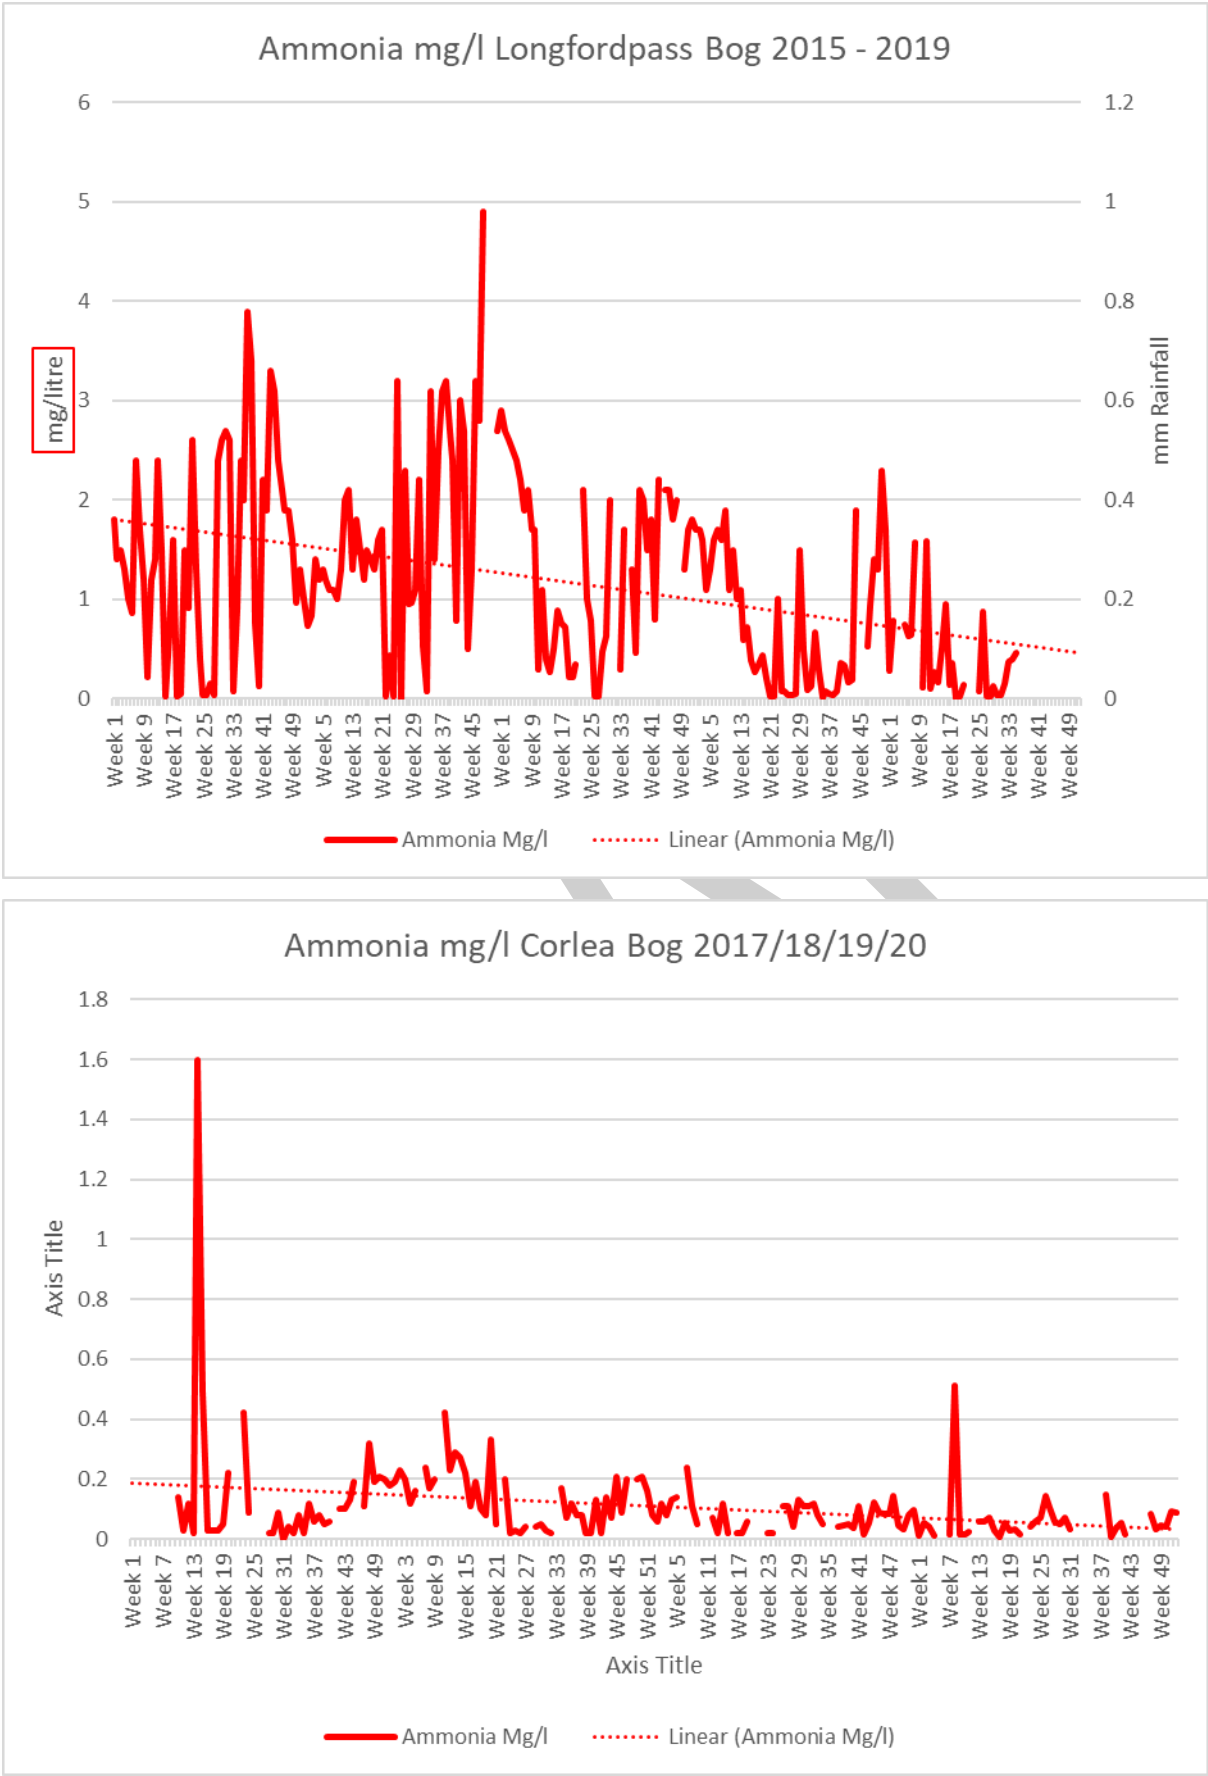
With regard to predicting and estimating likely trends that might materialize or could be considered as a target, monitoring of surface water ammonia emissions from Longford Pass bog in Littleton over 3 years, post cessation of peat extraction with ongoing rehabilitation, were considered. These are indicating a downward trend in Ammonia concentrations (Figure 7.1).

Similarly monitoring of surface water ammonia emissions from a Corlea bog in Mountdillon over the past 3 years post cessation of peat extraction with ongoing rehabilitation, indicate downward trends.

Figure 7-1: Ammonia levels over the period 2015-2019/2020 at Longford Pass and Corlea.
